## **TORISEAL Mechanical Seal Case History**

## **Boiler Feed Pump**

Plant Type: Combined Heat & Power Plant (CHP)

Pump Model: Halberg HSGA Multi-Stage Ring Section Pump

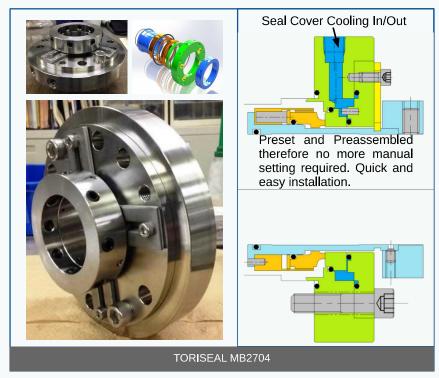
The previous seal installed was a non-cartridge component type seal. Component seals require manual setting and measuring during installation. Often, boiler feed pumps use adjusting rings to set the seals in the correct position. This can cause problems if not done correctly.

It was noted that there had been problems and premature failures with the previous seals. These failures were said to be the result of seal installation and setting errors by a previous maintenance service provider.

The local Torishima Service Solutions branch received these boiler feed pumps for repair and overhaul. During this phase it was decided to convert the seal type from non-cartridge to cartridge type. This gave the added benefit of quick and easy installation due to the cartridge being factory preset and preassembled. There were no irreversible modifications required to the pump and the seal cover cooling system of previous seal was implemented on the new TORISEAL cartridge design to ensure the cooling efficiency was equal or better.
