CASE STUDIES

# Mechanical Services

# Side Stream Pump Overhaul & Test

# Critical Cooling Pump Overhaul & Test

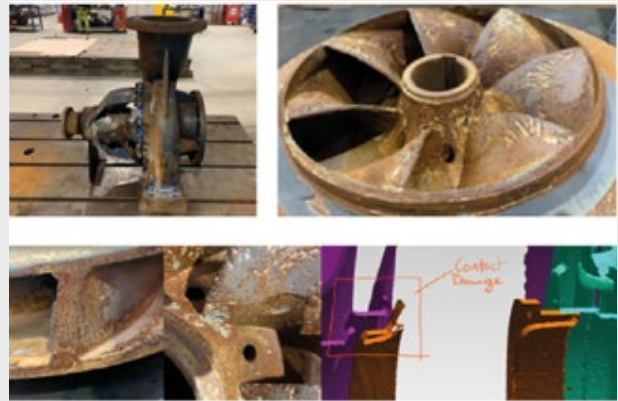
Torishima was tasked with the overhaul for a Side Stream Pump (Model: AZ 250-400) installed in 2002 for one of our clients. This pump had a rated power of 136kW and a pump duty of 1200m<sup>3</sup>/h generating 30m head and had a purpose of providing cooling water for side stream filtration in a cooling tower system. The customer reported pump failure due to the equipment being submerged in water, following a flood. Upon inspection of the pump, it was found that there was a bearing failure, the non drive end bearing had collapsed, the drive end bearing was excessively worn, and the circlip could not be located. This in turn had created excessive axial movement of the shaft and the impeller had run into the suction wear ring face,

causing 10mm of axial and radial wear on the end suction end of the impeller and internals of the casing. As a result, the shaft had heavy fretting on bearing locations and the shaft shoulder for the bearing was badly damaged.

To address these issues, Torishima supplied two new casing wear rings subject to API 610 running clearance to take up the radial gap, thus minimizing the volumetric losses. An 'L-Shaped' impeller wear ring was also supplied, recovering some of the axial wear on the impeller eye and acting as a buffer in preventing future wear in and around the area. Consumable parts such as bearings were replaced, minimizing the vibration. Upon further inspection, it was found that it was the repeated loosening of the lock nut on the end of the shaft that caused the damage to the shaft. To prevent the impeller lock nut loosening in the future, Torishima supplied a newly designed lock nut to fit a propriety

(ISO9001) 'Nord Lock Washer,' creating a wedge effect underneath the bolt head or nut. Torishima tested the unit post overhaul, after renewal of the internal clearances and repair, the verified results found a 6% increase on the efficiency when compared to that of the original test. This highlights the excellent work carried out by the Torishima engineering team and will now reduce the customer's net spend required to operate the pump.

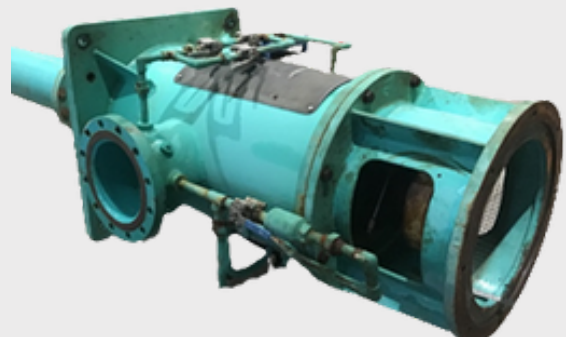
The pump was taken from site in February 2022 and brought to the TSSE's Glasgow facility where it was then disassembled and inspected by our technical team. It was found during inspection that the rotating element was subject to extensive wear and damage. The unit was also extensively corroded on the internals.

The extensively damaged shafts were beyond economical repair, Torishima Service Solutions Europe reverse engineered the new shafts to the OEM standard required where they were fully checked and tested to the Torishima manufacturers standards and tolerances. Consumable parts such as bearings were replaced, the rotor was fully balanced to ISO 1940 standards to minimise vibration at site. Corroded areas were cleaned and checked for residual material thickness to ensure they were within allowable tolerances.

The pump was internally and externally coated to NORSOK M-501 coating standards and verified using the NACE approvals process to ensure maximum corrosion protection for the unit going forward within the installed environment. TSSE testing the unit post overhaul, after renewal of the internal clearances and repair, the verified results found a 1.5% increase on the efficiency when compared to the of the original test. This highlights the excellent work carried out by TSSE engineering team and will now reduce the customer's net spend required to operate the pump.

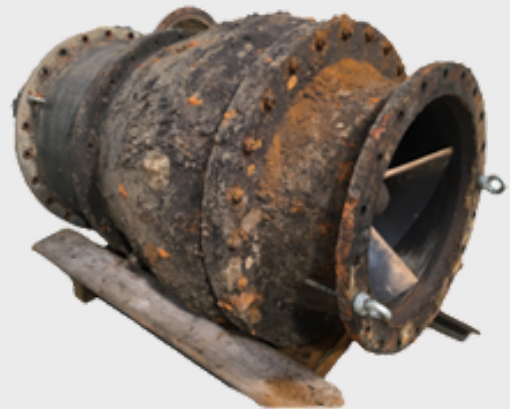
A total of seven land drainage pumps, originally installed in the 1960s and 70s, were overdue major inspection and maintenance works. TSSE were awarded the contract to carry out the inspections and any necessary repairs on four identical 36" pumps and three smaller 24" units at two separate pumping stations. It had been several years since the last intervention on any of the pumps and no record existed of the previous as found condition. Upon inspection of one of each set of pumps it was found that significant rework and modernising was required. This would require the manufacture of spare parts and redesigning of several components, including the shaft coupling arrangement & replacing an obsolete thrust bearing.

Upon inspection, it was found the impeller keys had deformed due to excessive keyway loads during operation. TSSE re-sized the keyways and optimised material selection to prevent this from happening in the future.

TSSE provided a hard faced HVOF upgrade to the shaft to prevent future galling. All wear rings were re-engineered to maximise the efficiency of the unit. The rotor was balanced to meet ISO 1940 standards, and the rebuild was completed on time to meet site operational requirements.

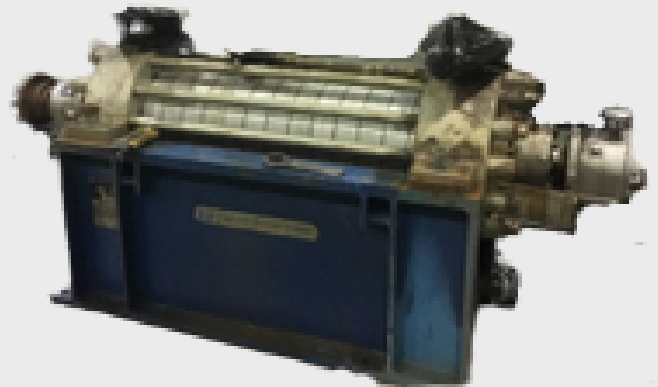
Upon receipt of the pump, TSSE performed all our routine strip-down and checks, providing a report back to site within 5 working days as standard. It was found the shaft run-out was out of tolerance, as well as being scarred, ovalled and undersized along the main body. All wear rings were also found to be out of tolerance to OEM classifications

Upon inspection, it was found the impeller keys had warped due to excessive torquing during operation. TSSE upgraded the keyway dimensions and optimised material selection to prevent this from happening in the future. To design out the scoring and undersizing on the shaft, the main body was oversprayed with an HVOF coating before final machining. All wear rings were re-engineered to optimise the efficiency of the unit. The rotor was balanced to meet ISO standards, and the rebuild was completed on time to meet site operational requirements.
