# Pressure Gauge Line - Permanent Blinding

Preventive action to eliminate risk of hot water entry through the PI line

# Heat Barrier Refurbishment

# Cooler Overhaul. Mandatory Inclusion

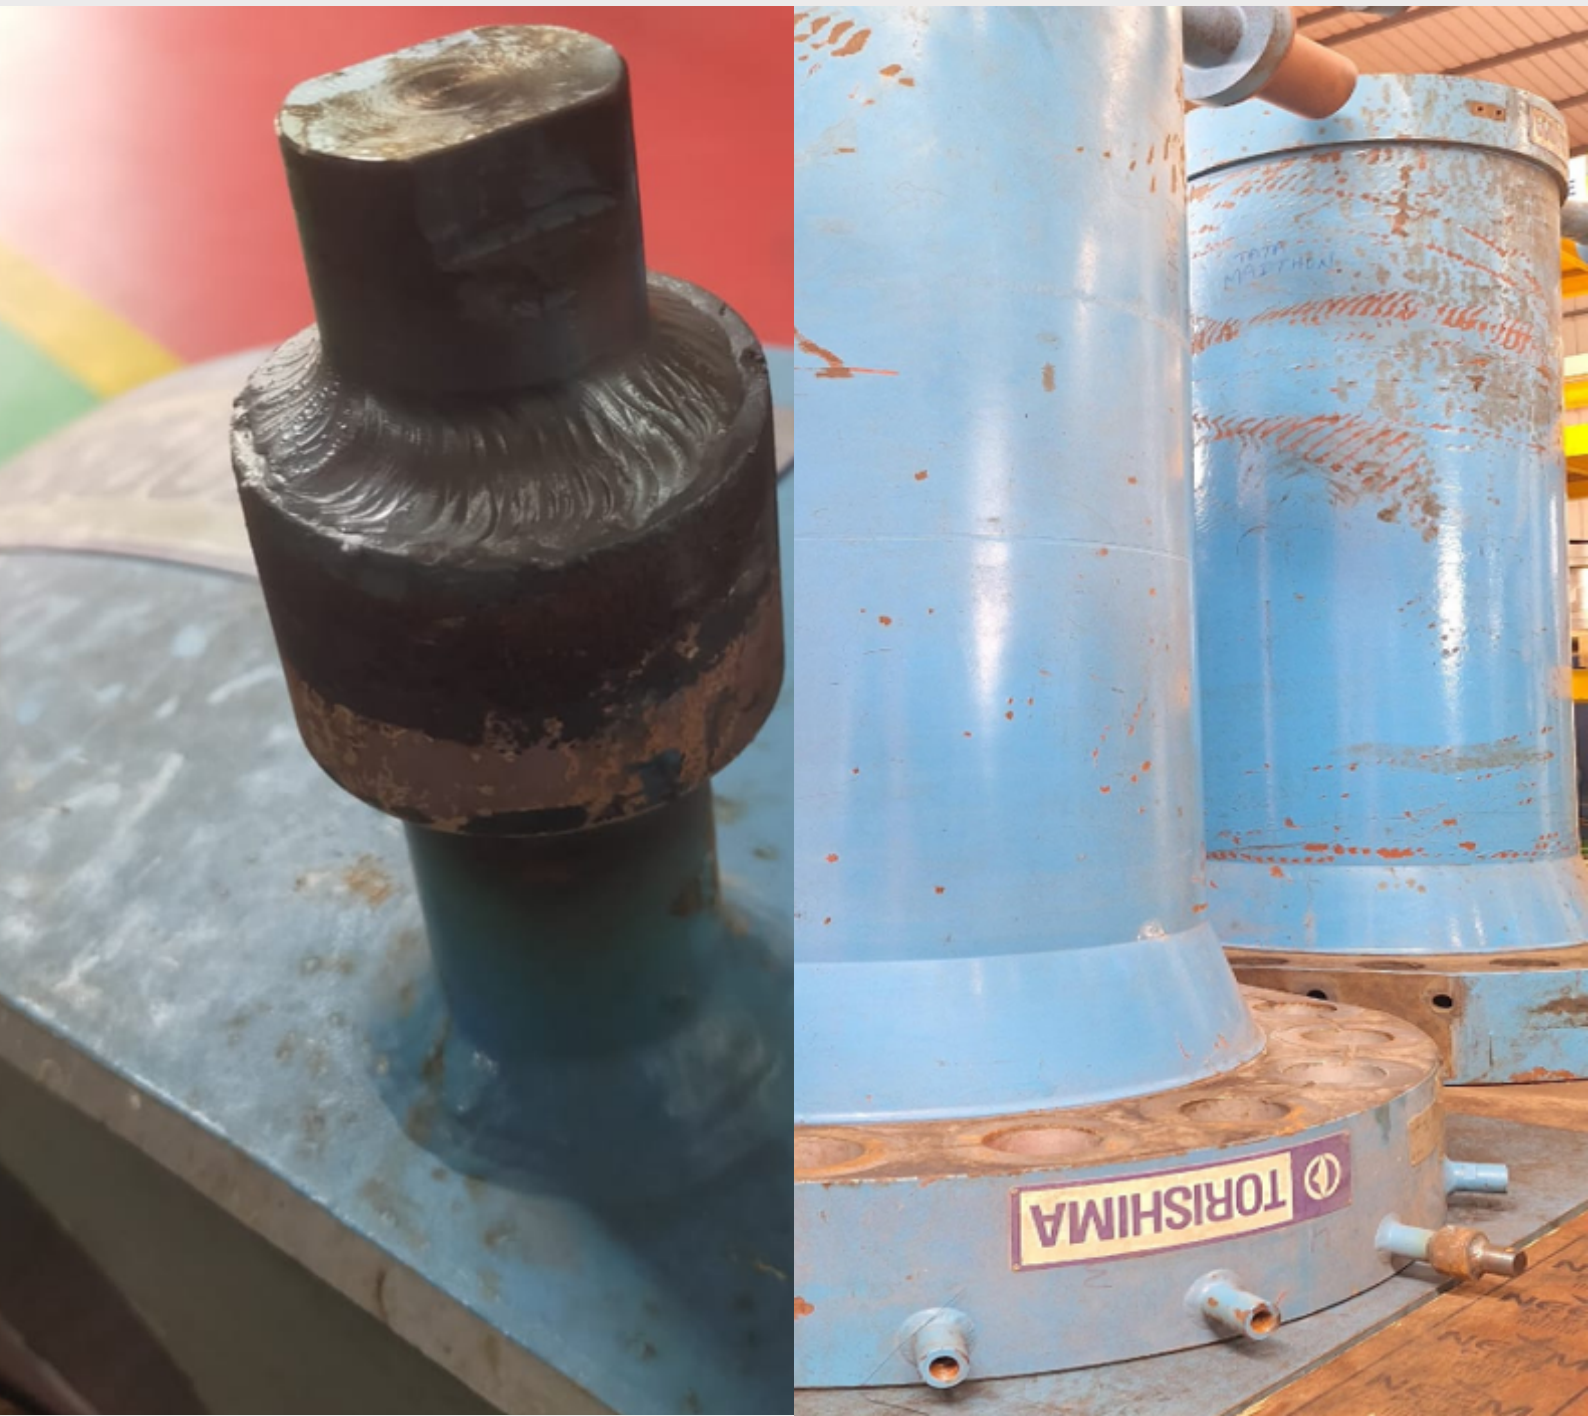
BCP (Boiler Circulating Pump) piping undergoes significant thermal expansion during operation - in excess of 300 mm. A pressure indicator (PI) line connected to the motor casing was vulnerable to this movement. If the PI line fouled with the platform structure due to insufficient expansion space or inadequate sliding support, the line could fracture.

A fractured PI line creates a direct path for high-temperature water to enter the motor casing, potentially causing catastrophic damage to motor windings and plain bearings.

To eliminate this risk permanently, the pressure indicator line connected to the motor casing is now permanently blinded (blocked off) during every major overhaul.

For newly manufactured spare BCPs, this line is no longer installed at all - removing the failure mode entirely from new equipment. A dummy plug is fitted at the pressure gauge point to seal the port cleanly.

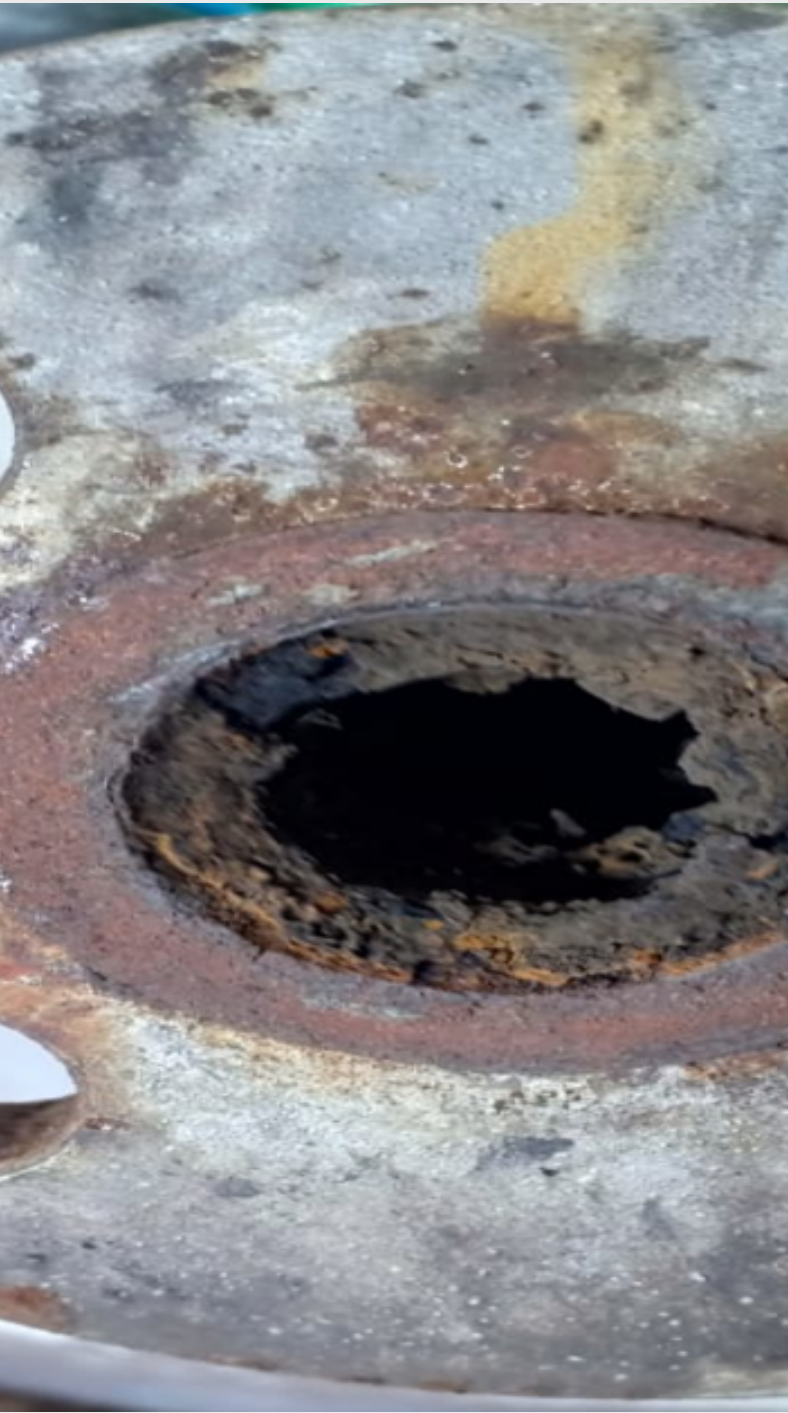
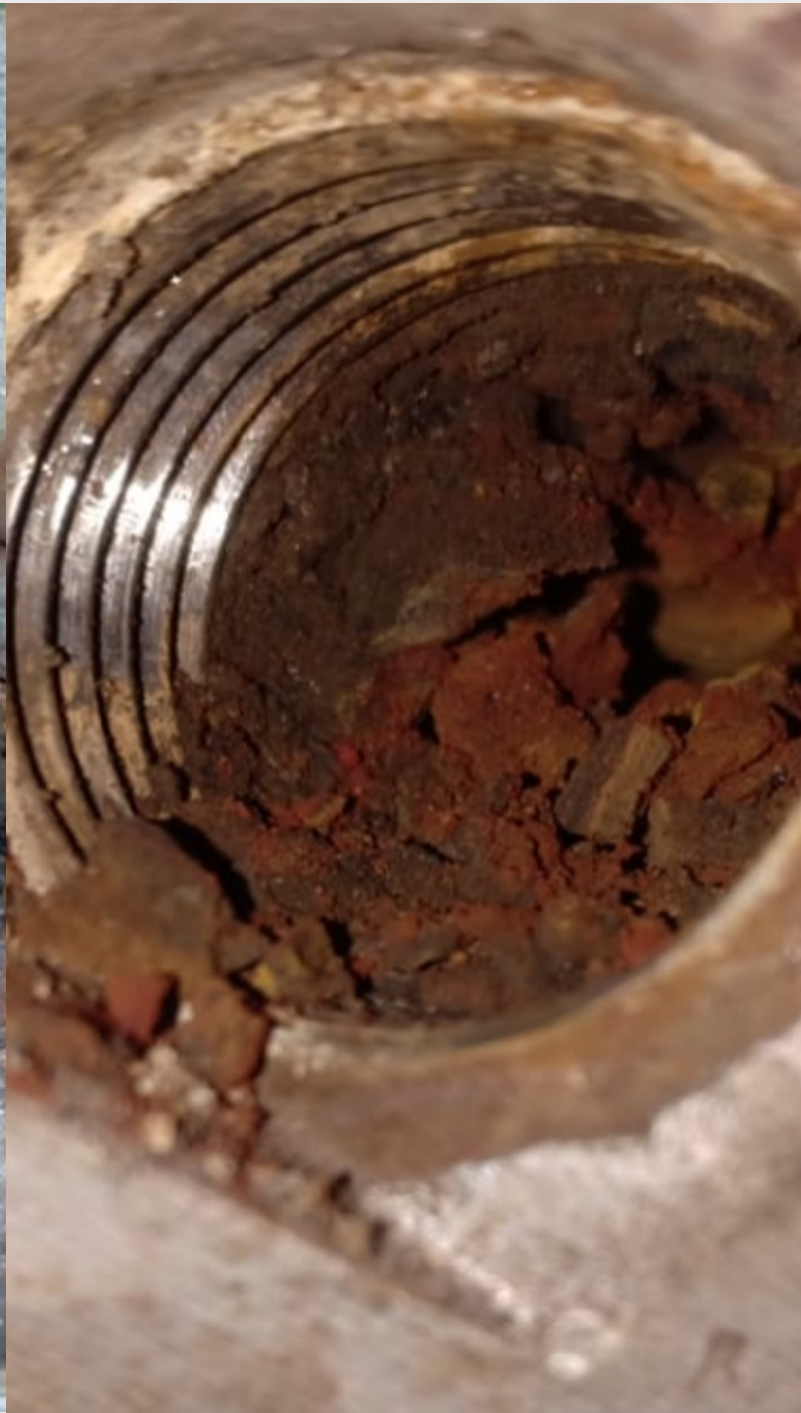
Restoration of cooling jacket effectiveness to ensure adequate motor protection

The BCP motor is protected from the high-temperature pump casing by a heat barrier, essentially a water-cooled jacket that forms a thermal shield between the two components.

Over time, the LP (Low Pressure) cooling water circulating through this jacket carries contamination and particulate matter. This causes the internal passages of the heat barrier jacket to choke (block up), significantly reducing cooling water flow.

A blocked heat barrier jacket results in insufficient cooling of the motor, leading to elevated operating temperatures and increased risk of thermal damage.

Heat barrier refurbishment by cleaning with High pressure water jetting and flushing has been incorporated as a mandatory activity during BCP overhauls. This includes disassembly, internal inspection, Mechanical water jet spray cleaning and flushing of the cooling jacket passages, and performance verification before reassembly.

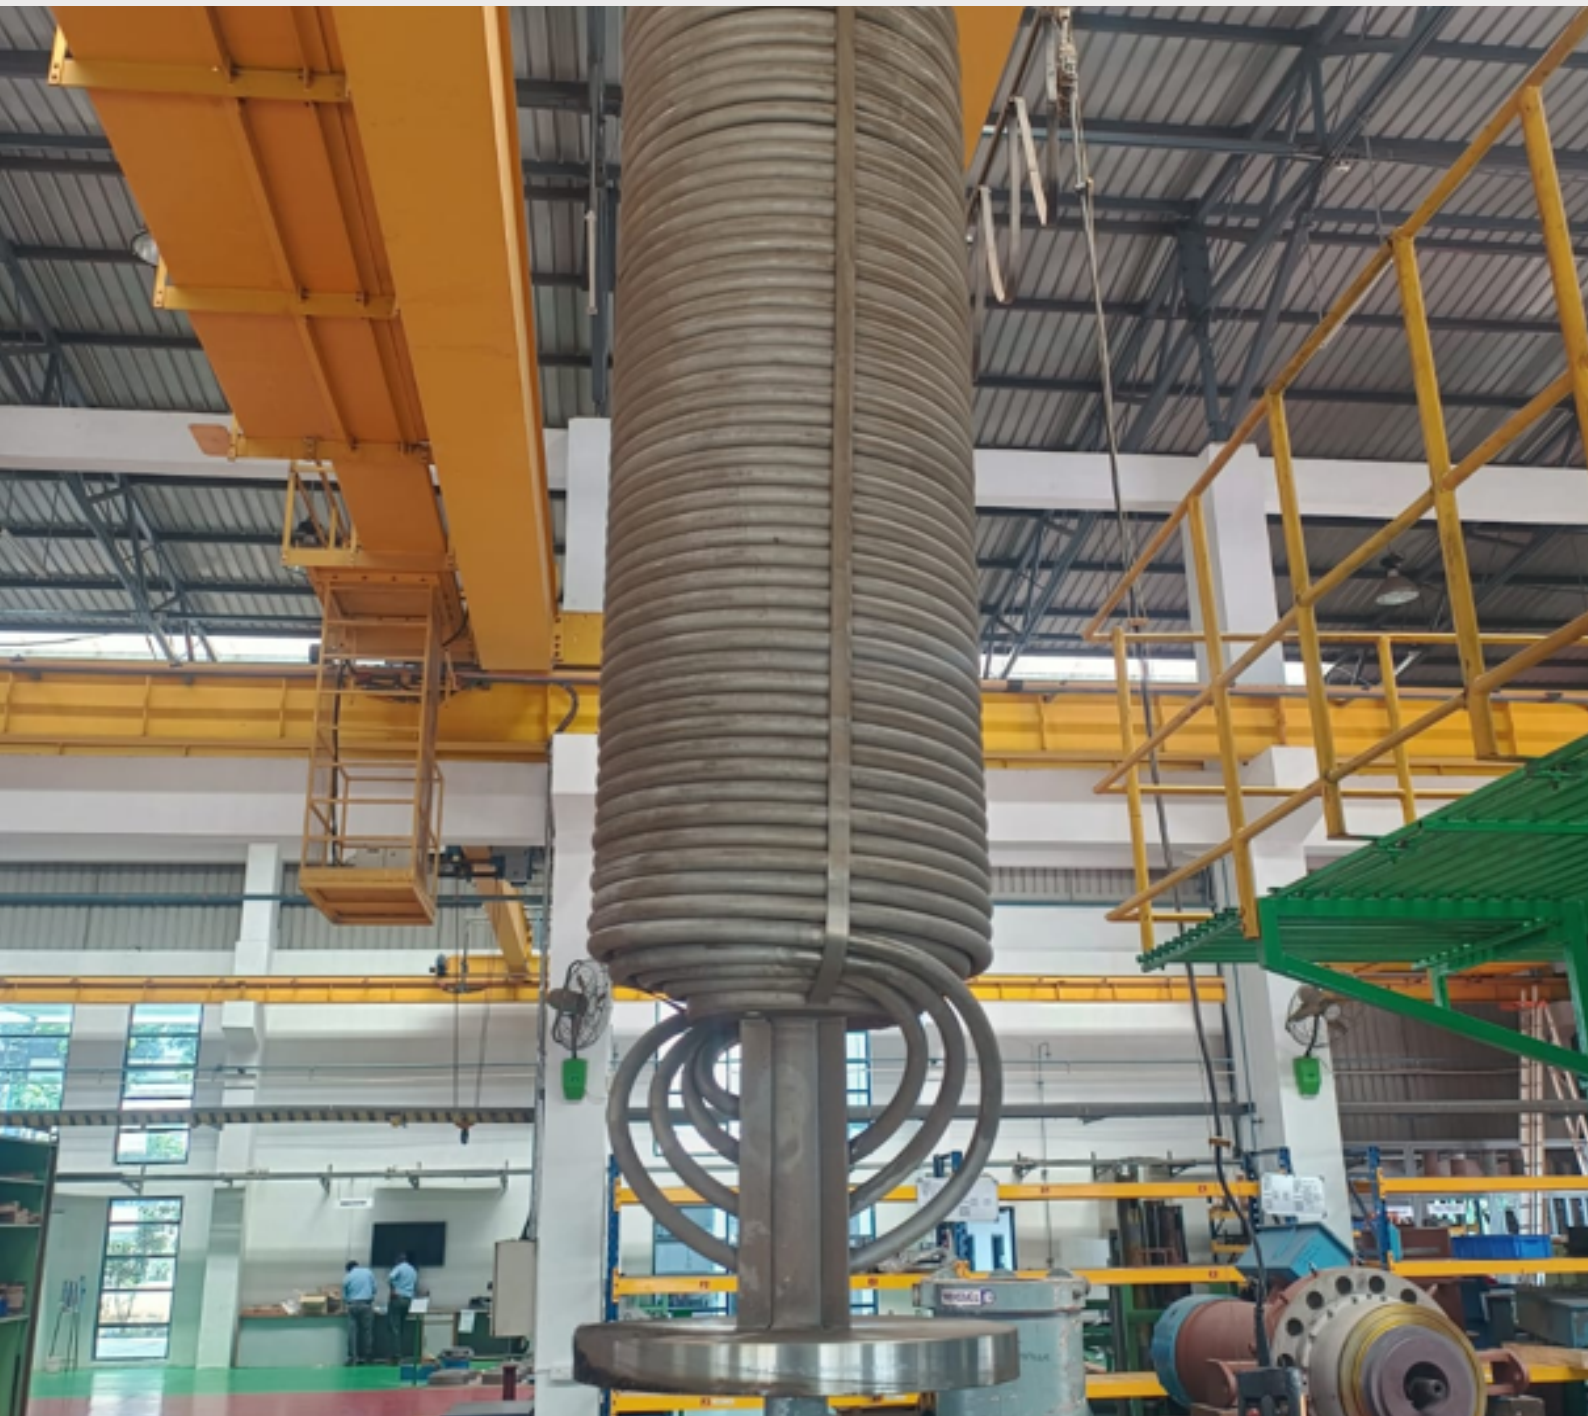
Addressing a gap in the maintenance schedule that affected pump performance

BCP major overhauls including rewinding are carried out on a 9-year cycle. However, the cooler - a critical component responsible for maintaining cavity water temperature - was historically not included in the overhaul scope.

Reduced cooling efficiency directly impacts BCP performance and can lead to increased cavity temperatures, accelerating wear on internal components.

Cooler overhaul has now been made a mandatory activity during every BCP major overhaul. The scope includes: internal cleaning of cooler tubes, tube inspection for damage or erosion, and performance verification after cleaning.

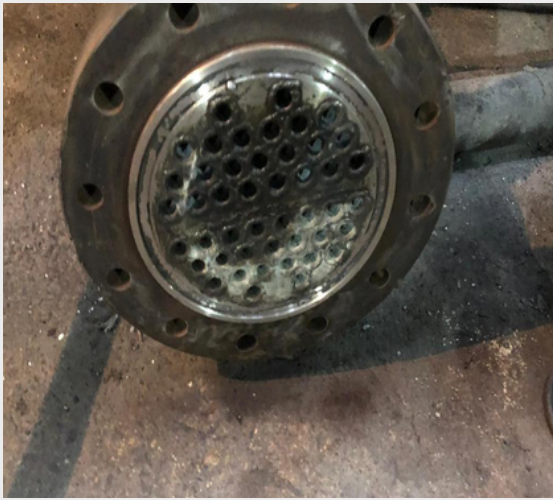
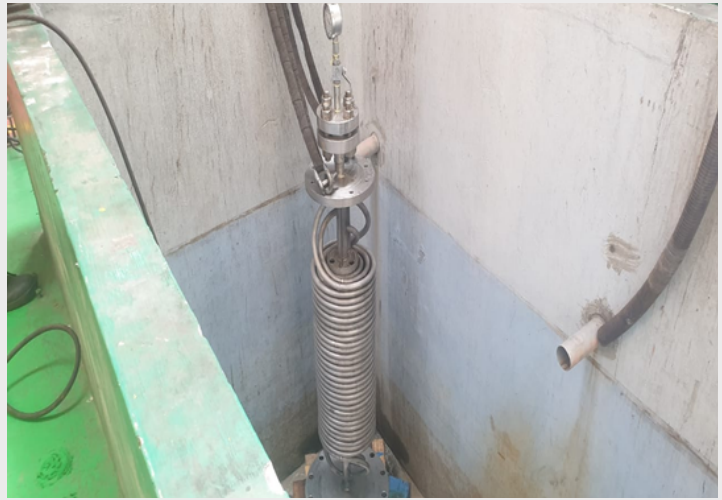
Two types of coolers are in service across BCP units - Torishima-supplied and BHEL-supplied. Both types are covered under this revised maintenance protocol.

## 2 Types of Cooler for BCP's: Torishima supplied & BHEL supplied

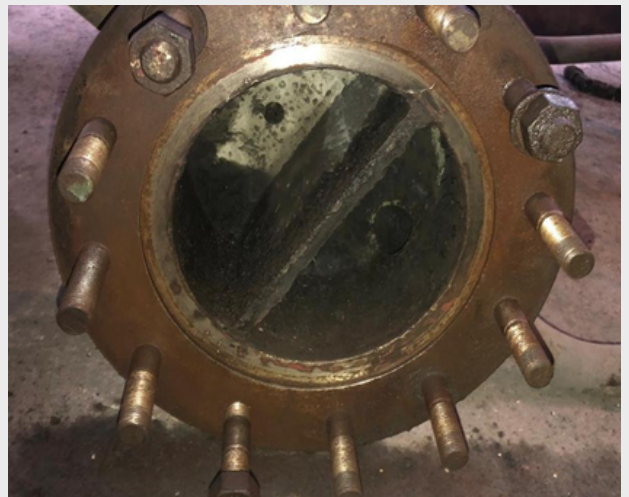
Cavity water circulates continuously through the cooler. Over time, magnetic particles from the system accumulate inside the cooler tubes. This progressive buildup reduces the heat exchange efficiency of the cooler.

## Cleaning of Cooler - BHEL supplied

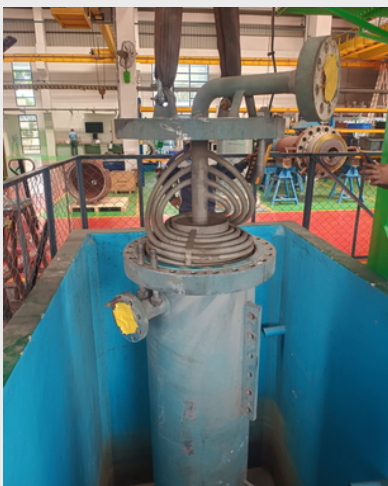
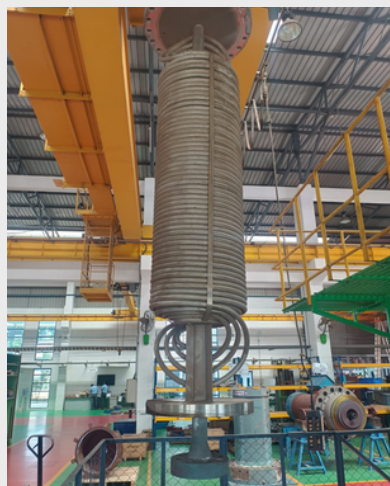
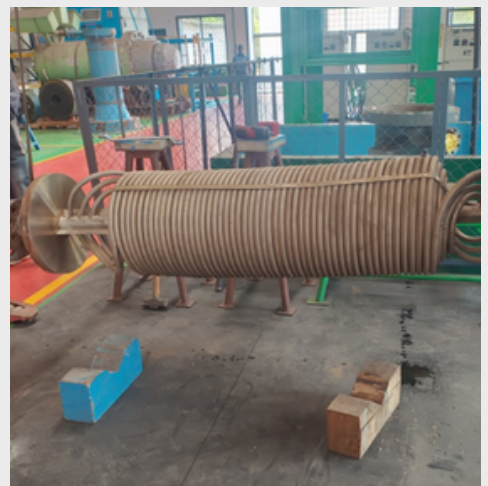
## Cleaning of Cooler - Torishima supplied
